# **Dynamic characterization of the Basilica of S. Maria di Collemaggio after the earthquake of 2009 by means of operational modal analysis**

## **Abstract**

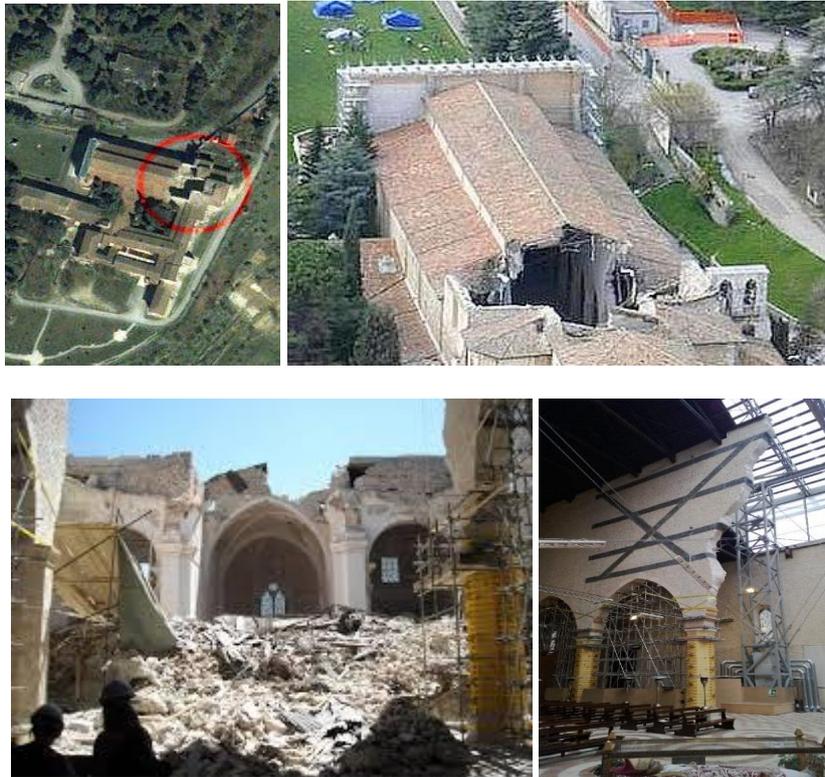
Figure 1: Earthquake effects

On April 6<sup>th</sup> 2009, the earthquake that partially destroyed the city of L'Aquila has caused the total collapse of all elevated structures in the transept of the basilica. It is manifested in the collapse of the wall of the triumphal arch, of terminal pillars of the nave, of the vaulted structures and those of coverage, resulting in a pile of rubble inside the box walls, remained broadly intact and complete up to the top portion. To provisional safeguard, waiting for a comprehensive restoration, a series of measures have been put in place with the intention of providing a monolithic behavior of the box walls. Arches were discharged with underpinnings, pillars were rimmed with polyethylene tape, different systems of shackling active transverse and longitudinal bars along the

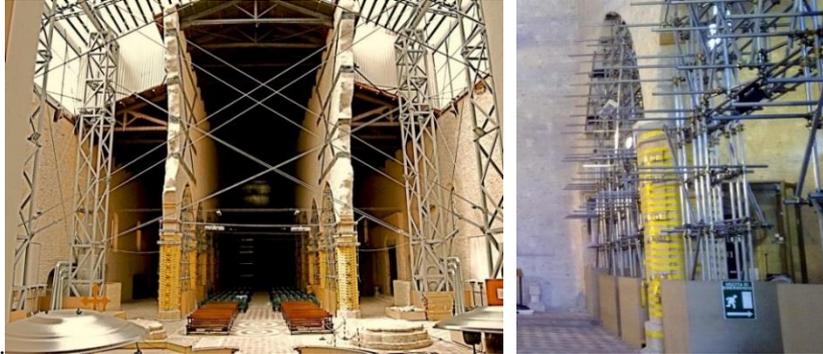
Figure 2: Provisional measures

nave and in the apse were applied, carbon fiber prepreg tapes were applied to masonry elements, especially at the ends where fractures occurred, trusses to support the apse vaults have been put in place.

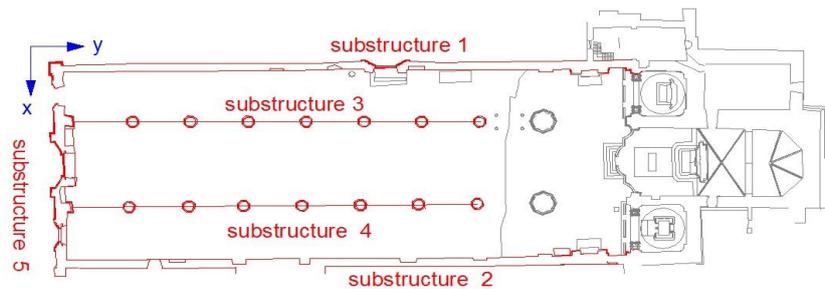
Figure 3: Surveyed substructures

Referring to the operational steps, the accelerometers were installed separately, for each phase, on structures from time to time under investigation (substructures). For each of them the arrangement has been driven by considerations about the visually observed conditions of damage and about the conceivable and expected modal shapes. For the impact testing two measurement runs were conducted to cover all points planned. The accelerometers were placed in both mono-axial and bi-axial configuration.

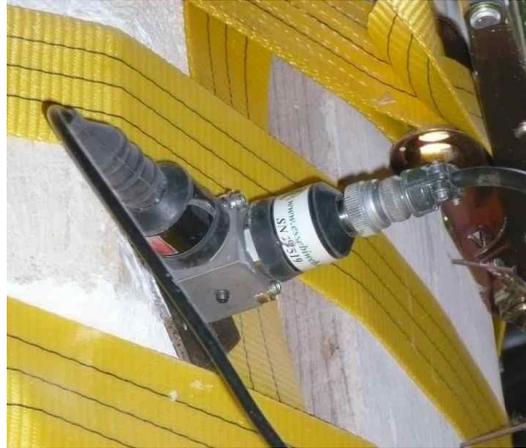
Figure 4: IEPE seismic accelerometer settled on a pillar

IEPE seismic type accelerometers (high-sensitivity, low noise and capable of sampling at low frequencies) have been utilized: PCB 393A03 (sensitivity 1 V/g, range  $\pm 5$  g resolution 10  $\mu\text{g}$  rms, minimum measurable frequency of 0.2 Hz  $\pm 3$  dB) and PCB393B12 (sensitivity 10 V/g, range  $\pm 1$  g resolution 8  $\mu\text{g}$  rms, minimum measurable frequency of 0.05 Hz  $\pm 3$  dB). The characteristics of the PCB 086D20 instrumented impact hammer are the following: sensitivity 0,23 mV/N, full scale 22240 N, resonance frequency  $\geq 12$  kHz. The synchronization of two or more acquisition systems depicts an optimum solution when it is necessary to have many lines of data acquisition simultaneous sampling, with reference to sensors which are very distant between them. Using a single acquisition system would be needed long cables with consequent loss of quality in the signal and difficulty of installation. With the solution applied in this work, however, each of the two systems has been linked to sensors placed on limited portions of the structure via length short cables (25 m max).

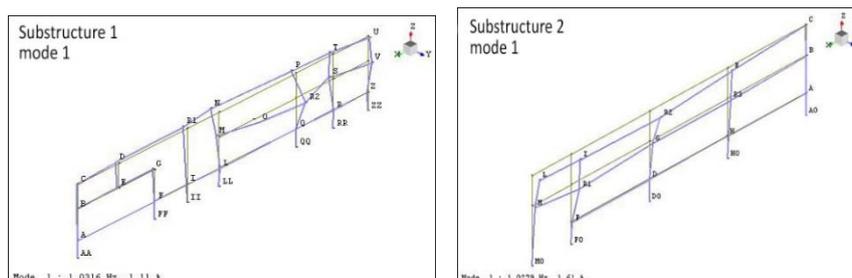
Figure 5: First mode shapes for substructures 1 and 2

For extracting modal parameters has been used the LMS PolyMAX algorithm that is a further polyreference evolution of the least-squares complex frequency-domain (LSCF) estimation method, based on a so-called right matrix-fraction model. In this approach, also the participation factors are available when constructing the stabilization diagram [7]. The main benefits of the polyreference method are the facts that the singular value decomposition (SVD) step to decompose the residues can be avoided and that closely spaced poles can be separated [8]. Herebelow the most significant mode shapes with relative modal parameters are listed for each substructure investigated. The substructure 4 was divided into two portions: the first more limited close to the entrance area, the second towards the transept.

For structures from 1 to 4, the surveys, with transducers spreadly distributed on the walls, led to the determination of a flexural first mode between 1.02 and 1.04 Hz, with damping of the order of 1%. For higher modes, although the well-

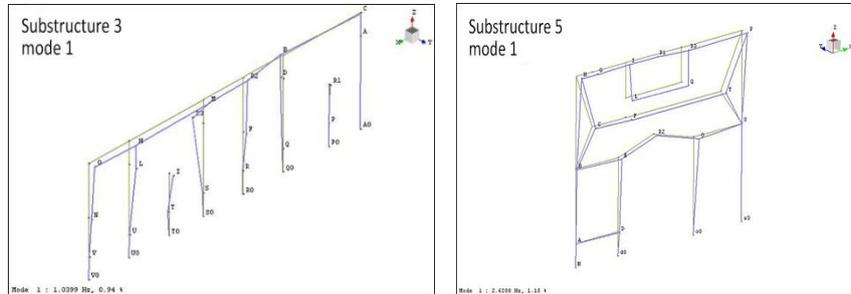
Figure 6: First mode shapes for substructures 3 and 5

The substructure 5 shows the main façade characterized by higher frequencies than the other four substructures. This is due to greater rigidity in part constitutive and in part favorite to persistent constraint conditions with males orthogonal to it. The façade still shows a significant loosening, much more than what has been reported for the other substructures, compared to what can be deduced from the investigation prior to the earthquake.

Not surprisingly, the façade is found placed almost perpendicular to the direction of seismic wave front, undergoing an oscillatory motion out of the plane that has resulted in plasticization and brittle failures more or less widely.

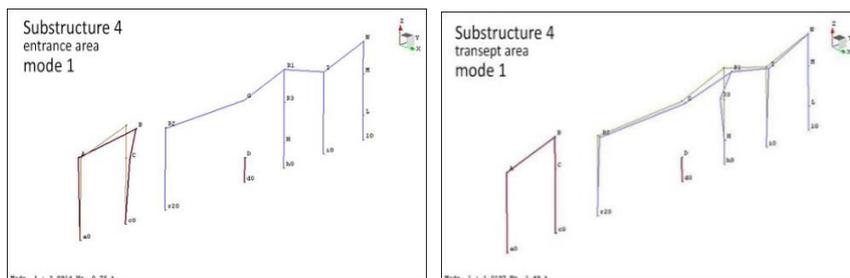
Figure 7: First mode shapes for substructure 4

For the substructure 4, it was conducted a double analysis which allowed to identify a behavior that differs along the longitudinal development: for the most of the development, towards the transept, the value of the frequency of the first mode is aligned with that of the other substructures, it almost double nearly the confluence with the main façade, demonstrating a greater stiffness determined by the constraint with it.

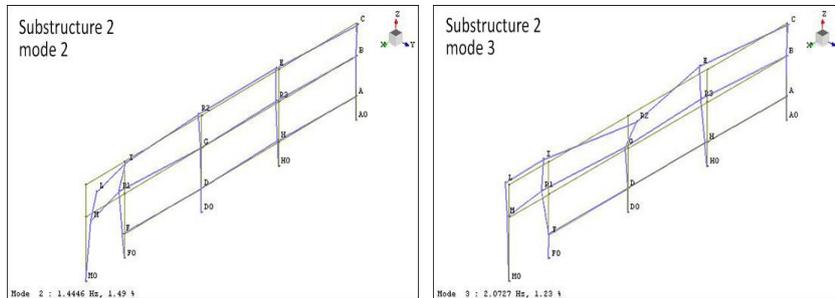
Figure 7: Second and third mode shapes for substructure 2

For the substructure 2 also the second and the third mode are represented. For comparison, also the first two modes obtained with the impact testing relative to the first three substructures taken together are represented.

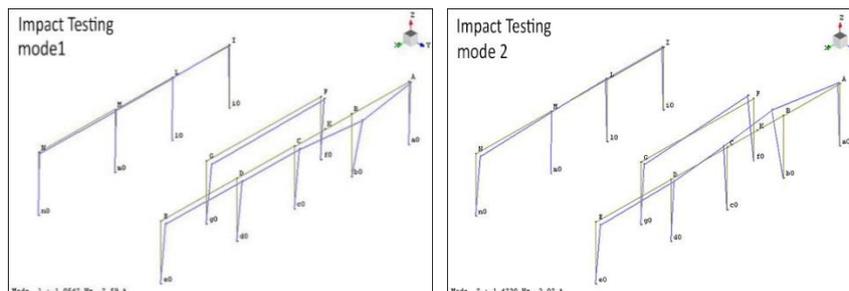
Figure 8: First and second mode shape obtained with the impact testing
